**EMPRESA
COLOMBIANA DE
PETROLEOS
ECOPETROL**

**REPORT ON THE STEAM LINE REPAIRS USING THE
PIPE REPAIR AND REINFORCEMENT SYSTEM SYNTHO GLASS®**

The following is our final report on the repairs made using the Syntho-Glass System on the ½" diameter steam inlet and condensate outlet lines on the chimney.

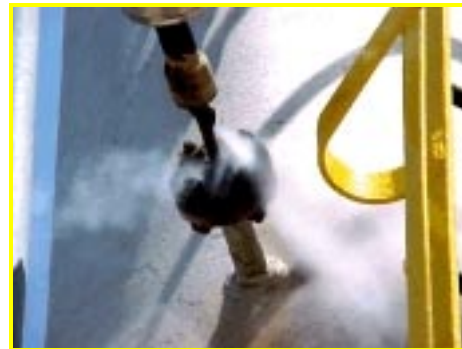
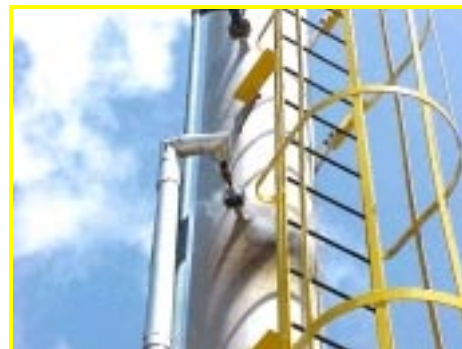
11:00 – Arrive site. The two leaks and their location is easily visible. The line is closed off and a fire fighting hose is used to cool down the line.

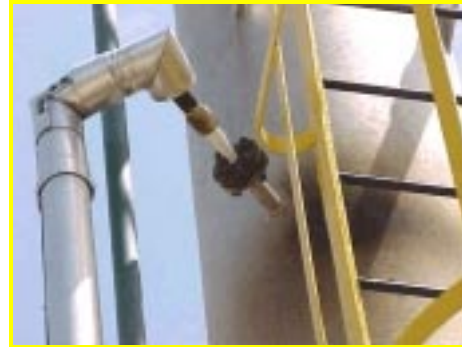
11:10 – The cleaning of the repair area is begun using sand paper. After this cleaning, the two repair areas can be seen to be very corroded and the diameter of each hole is expanded to completely clean and remove the corrosion. After this, the upper repair is approximately 1" diameter and the lower, approximately ¾".

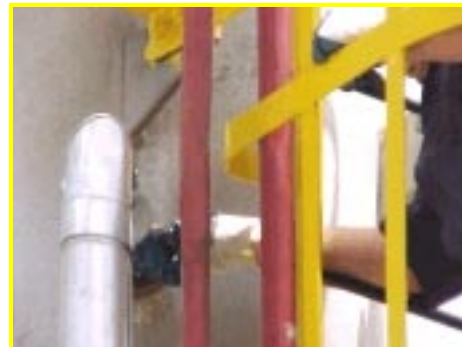
11:40 – The cleaning of the two defects is finished. This has taken longer than normal due to the location of and limited access to the repairs. The final area is cleaned to white metal.

11:45 –Syntho Steel Epoxy is applied to the holes to seal the leak. This procedure is accomplished rapidly due to the heat of the pipe, which causes the epoxy to cure almost immediately.

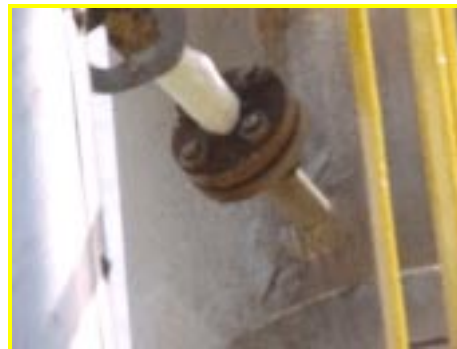
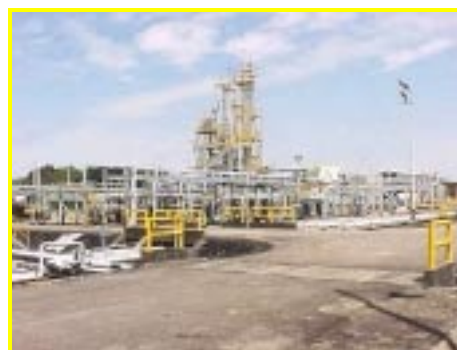
14:00 – The steam line is reopened and the leaks have been repaired.

12:20 – End of the repair. In agreement with Sr. Freddy Pérez, the lines will be reopened at 14.00 hours.
