SERYE SERVICIOS

Santafe de Bogota D.C., julio 20 de 2000

**SEÑORES:
PETROBRAS INTERNATIONAL
CAMPO YAGUARA
ING. OTTO MORALES
Yaguara - Huila**

REF: REPORT ON THE HYDROTEST OF THE SYNTHO-GLASS® REPAIR AND REINFORCING SYSTEM

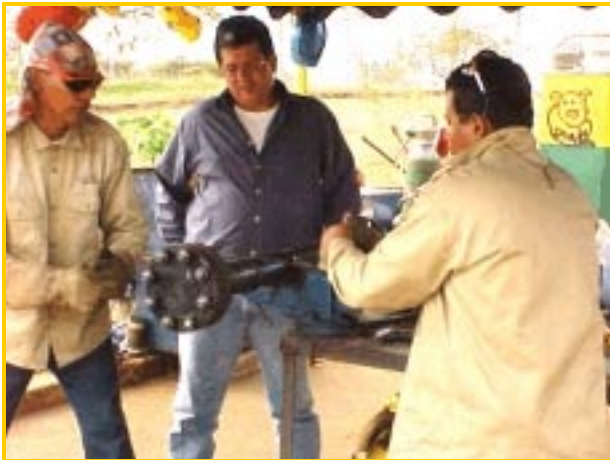
Figure No.1 -Cleaning to White Metal the Repair Area for Defect "A"

In the areas where the defects were to be made, the metals was ground to white metals (See Figures 1 and 2)

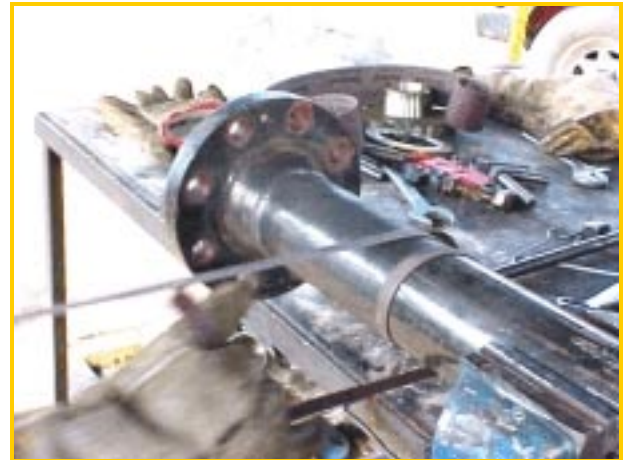
Figure No.2 - Cleaning of the Area for Defect "B"

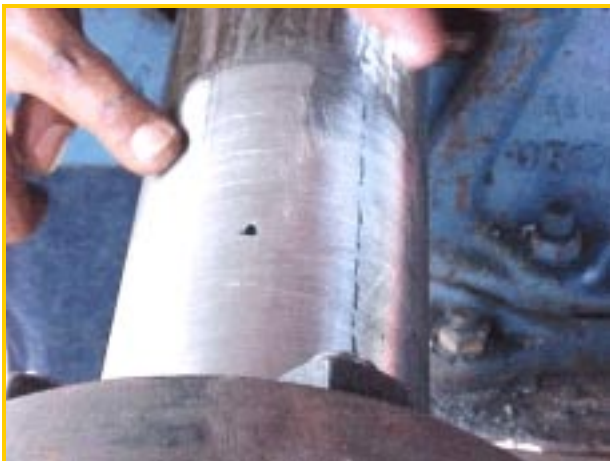
Two defects were made to the probe: one a hole approximately 1.5 cm in diameter (Defect "A") and the other, an internal wall loss of 70% (Defect "B").

Figure No.3 - Hole

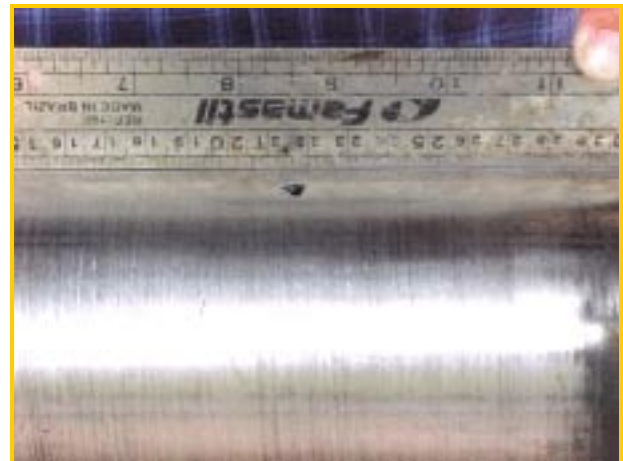
Figure No.4 - Dimensions of the Hole

For Defect "A" (Hole), a minimum of 8 layers should be applied. This minimum amount of layers (8) will guarantee a pressure retention up to 600 psi. Because this Defect has a remaining operating pressure of 0 psi, we based our calculations on burst pressure of 5000 psi . Table No. 1 shows the information for Defect "A".

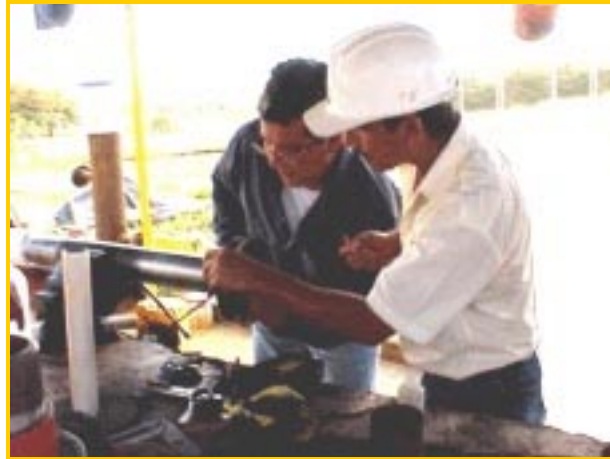
Defect "B" (Internal Wall Loss), was approximately 1" long and oval in shape. The remaining wall thickness was measured using a Ultrasonic Tester (Figure 5). Table no. 2 shows the details of this defect. The repair was calculated to reach 5000 psi.

Reviewing this data, the pipe with this defect should burst at 1,044 psi.

Figure No.5 – Measuring the Remaining Wall Thickness in Defect “B”

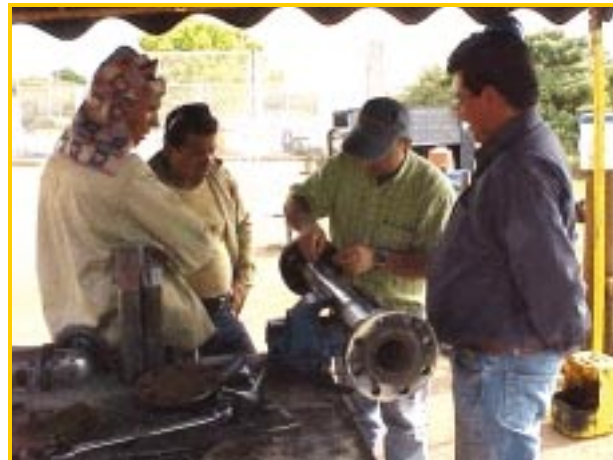
Figure No. 6 – Application of Syntho Steel

As the surface area of the repair had been prepared, the hole was sealed using Syntho-Steel, a 2 part epoxy putty which provides an effective seal.

The cure time for this putty is 5 minutes, during which any excess is cleaned away using an abrasive medium.

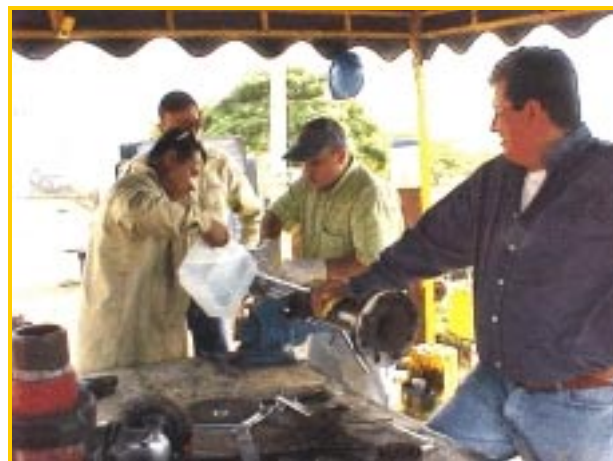
Figure No. 7 – Application of Syntho Glass®

The application of Syntho Glass® is begun over the area of Defect "A". The Syntho-Glass® is applied around the pipe and water is applied to activate the resin. Care must be taken to remove any wrinkles or gaps between layers.

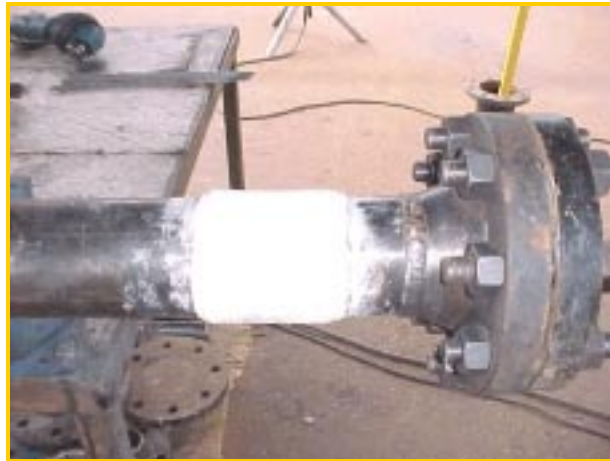
Figure No. 8 – Repair to "A" Completed

Once the Syntho Glass® has been applied, it is wrapped in a vinyl paper to contain the resin during its cure. Holes are punched into this covering to allow the release of CO₂ produced by the reaction of the resin with the water. By releasing the CO₂, this allows the water to migrate up to the surface of the last layer of Syntho-Glass® so it does not remain between the pipe wall and the first layer of Syntho Glass®.

The vinyl is removed after 15 to 20 minutes when Syntho Glass® has begun to harden. Figure no. 8 shows the completed repair to "A".

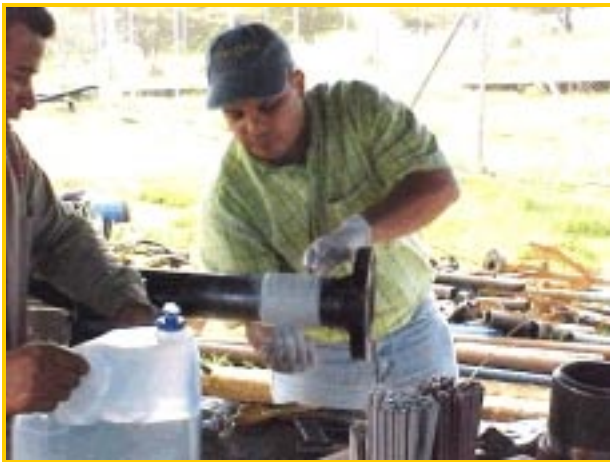
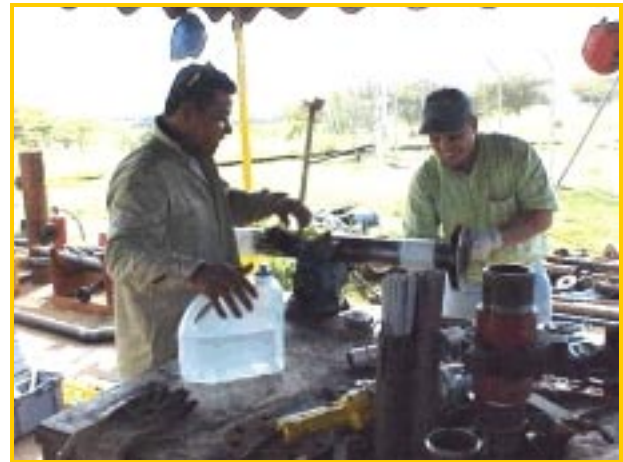
Figure No. 9 – Applying Syntho Glass® to Repair "B"

Figure No. 10 – Applying Syntho Glass® to Repair "B"

The procedure was the same. Syntho-Glass® was applied over the pipe, applying water and manually molding and squeezing the tape to assure the proper adhesion between layers and a monolithic finish.

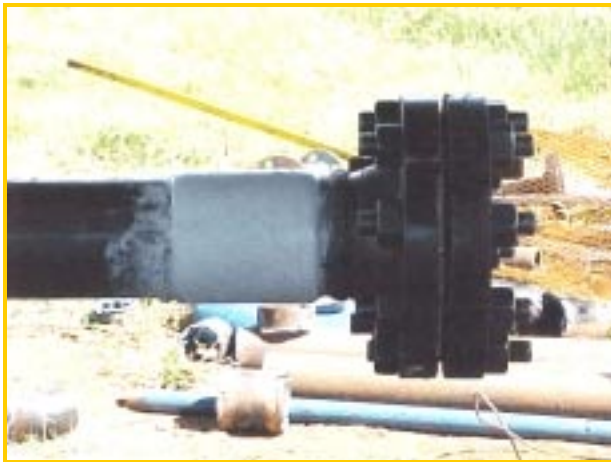
Figure No. 11 – Repair "B" Completed

After the application of the required layers, the vinyl paper was applied to maintain the tension. This wrap remain until the Syntho-Glass® had hardened. Figure No. 11 shows the finished repair "B" and Figure no. 12, the completed and repaired probe.

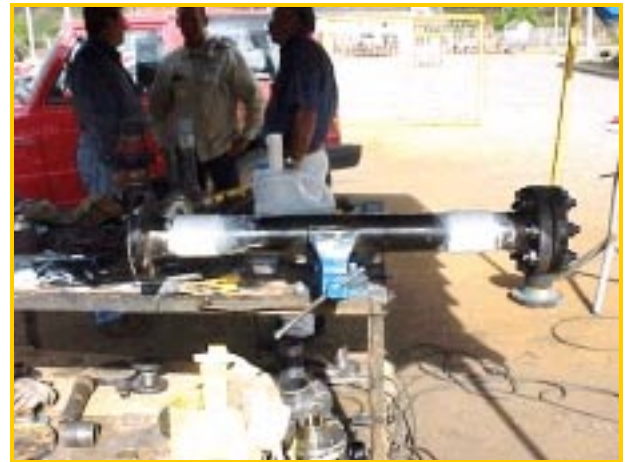
Figure No. 12 – Repaired and Completed Probe

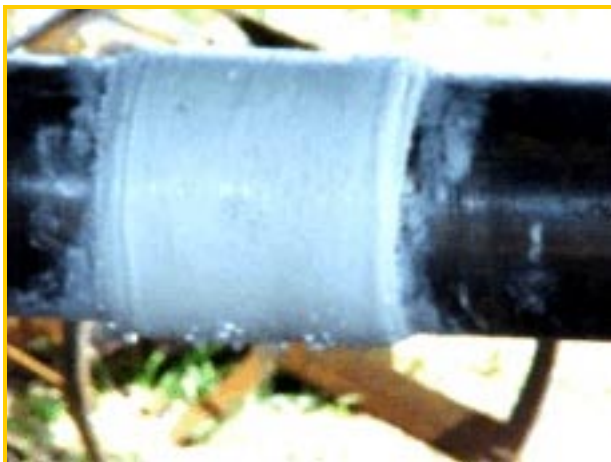
Defect "A" failed at 2,000 psi (Figure No. 17). The Syntho-Glass® Sleeve was removed (Figure No. 18).

Figure No. 17 - Failed @ 2,000 psi

Looking at the failure, the Syntho-Glass® sleeve suffered no damage; the failure occurred in the Syntho-Steel Putty but no cracks or fractures were seen. To continue with the test, the Syntho-Steel was removed and the hole was welded off.

- If a higher degree of pressure retention is needed for holes or fissure repairs, Syntho Steel Epoxy Mastic can be used. This epoxy resin is reinforced with steel fibers and will have a higher mechanical properties than the Syntho Steel Epoxy Putty.

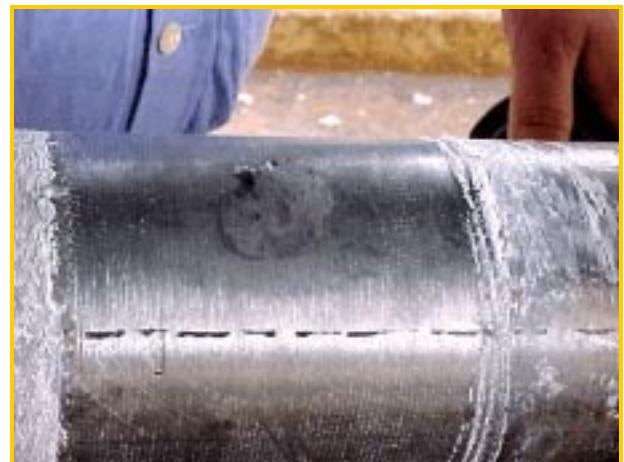
Figure No. 17 - Defect "A" after Removing the Syntho Glass Sleeve
