SERYE SERVICIOS

Santafe de Bogota D.C., julio 20 de 2000

**SEÑORES:
PETROBRAS INTERNATIONAL
CAMPO YAGUARA
ING. OTTO MORALES
Yaguara - Huila**

REF: REPORT ON THE HYDROTEST OF THE SYNTHO-GLASS® REPAIR AND REINFORCING SYSTEM

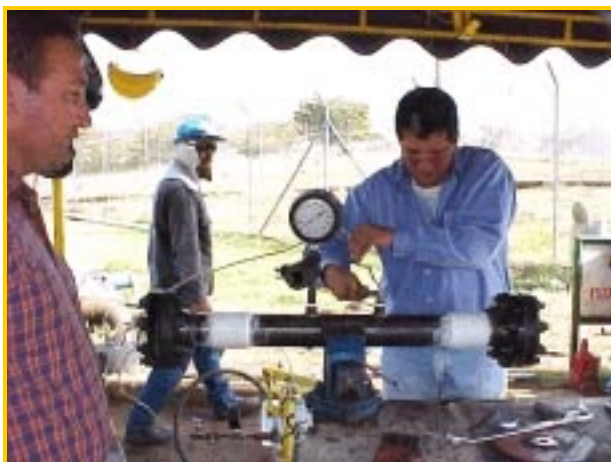
Figure No. 13 – Installing Pressure Gauge and Pump

The Burst Test was made 17 hours after the repairs had been completed. The Pressure Gauge (5,000 psi) was installed and the Baker Pump was connected to the probe. (Figures 13 and 14).

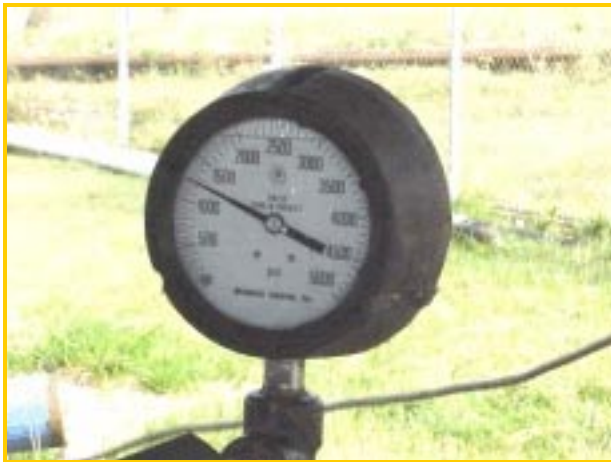
Figura No. 15 - 1,250 psi

Once the connections were made and the probe filled with water, Pressure was applied. The first increase in pressure reached 1,250 psi and the second, 2000 psi. This pressure was reached in 30 seconds. (Figures 15 and 16)

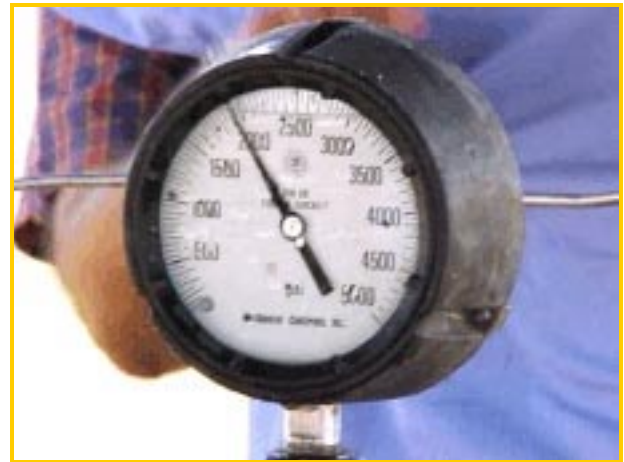
Figura No. 16 - 2,000 psi Presión de Falla

Defect "A" failed at 2,000 psi (Figure No. 17). The Syntho-Glass® Sleeve was removed (Figure No. 18).

Looking at the failure, the Syntho-Glass® sleeve suffered no damage; the failure occurred in the Syntho-Steel Putty but no cracks or fractures were seen. To continue with the test, the Syntho-Steel was removed and the hole was welded off.

- The repair of the hole failed at 2000 psi, 800 psi over the MOP of the Campo Yaguara lines
- The Wall Loss Repair met and Exceeded the established parameters of the test

- If a higher degree of pressure retention is needed for holes or fissure repairs, Syntho Steel Epoxy Mastic can be used. This epoxy resin is reinforced with steel fibers and will have a higher mechanical properties than the Syntho Steel Epoxy Putty.

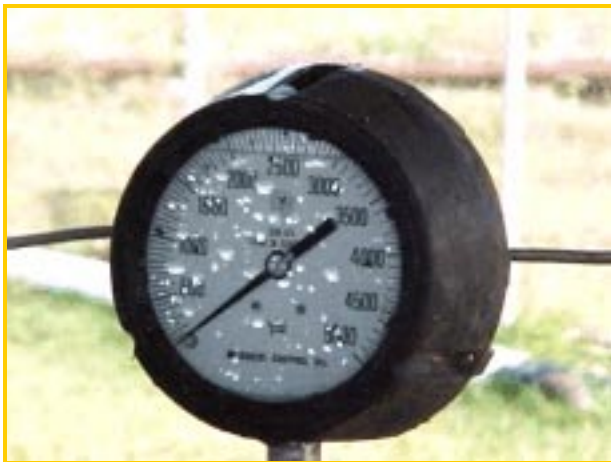
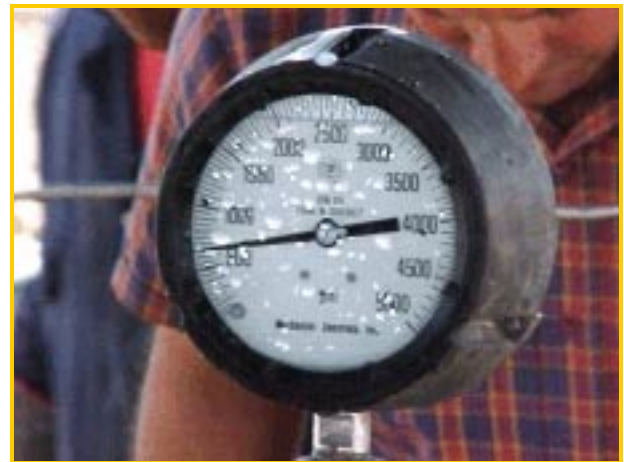
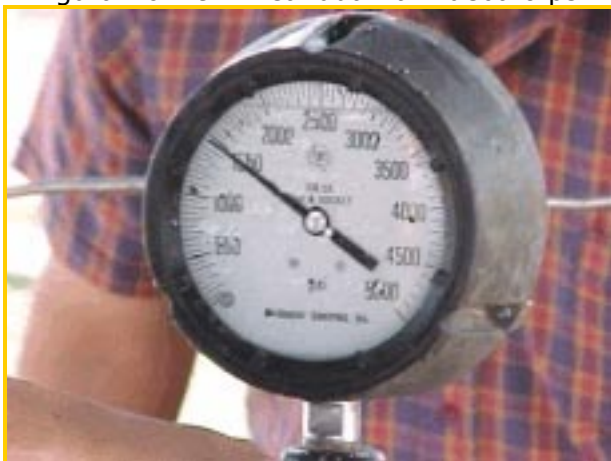
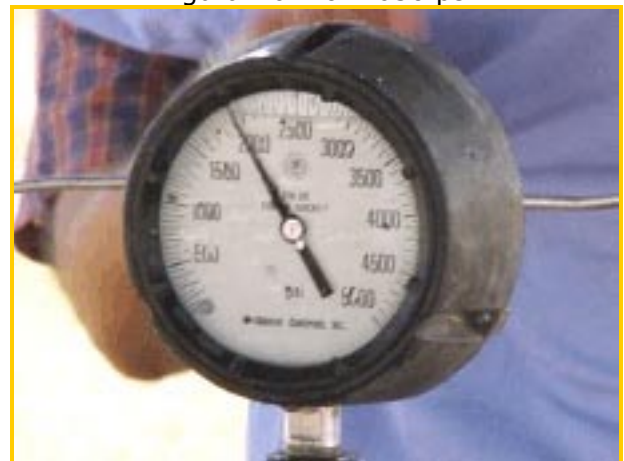
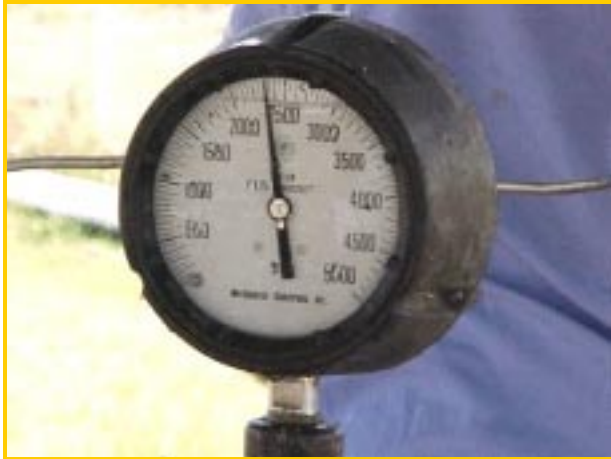
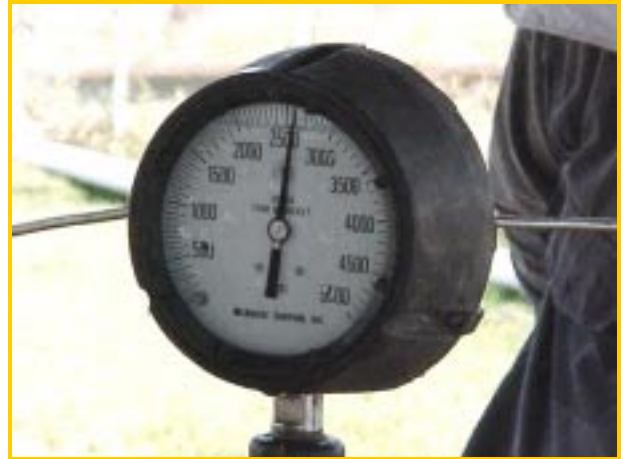
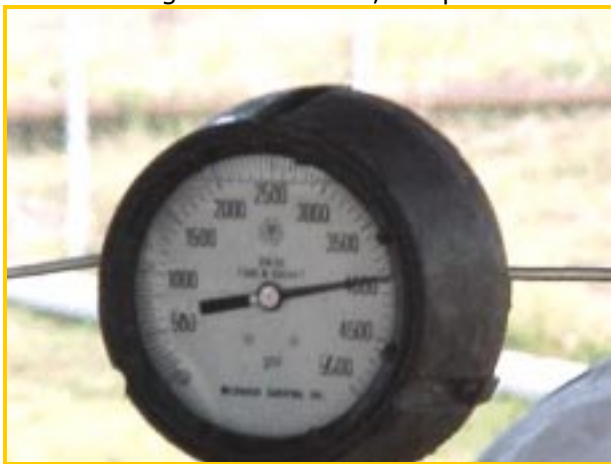
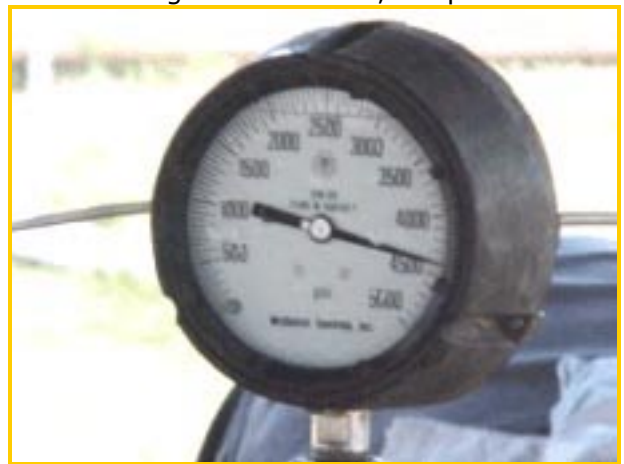
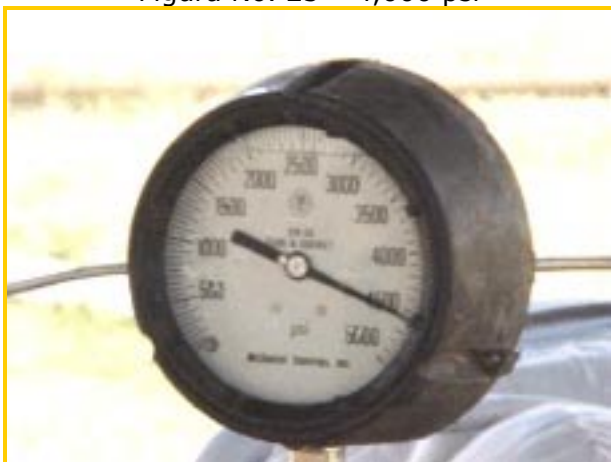
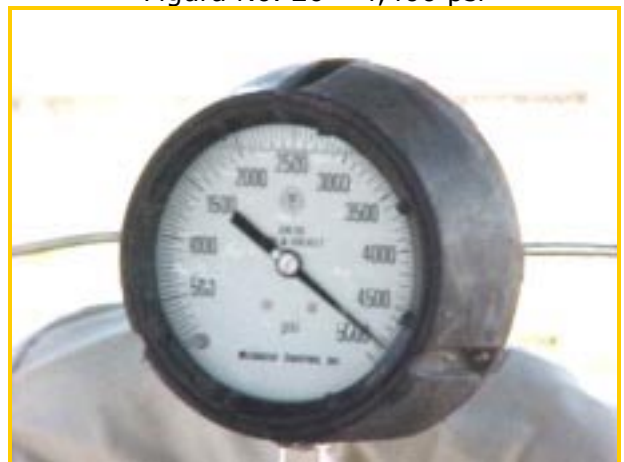
Once the hole was sealed off, the probe was refilled with water and pressure applied using the Baker Pump. The intervals between the increase in pressure were varied due to the difficulty in increasing the pressure by hand but we were able to reach 5,000 psi within 10 minutes. In the Figures 19 - 27 you can follow the increases in pressure.

The 5,000 psi limit of the pressure gauge was reached and at this pressure, leaks were observed coming from the threaded flange bolts on the blind flanges and it was decided to stop the test as it was impossible to further increase the pressure to burst pressure.

Once the test was stopped, pressure was bled out of the probe and Defect B was opened from the side to observe the status of the interior of the pipe. From this observation, Syntho-Glass prevented a rupture of the pipe.
